Failure Analysis of a Cracked CH-47 Swashplate Rotating Ring, S/N BCW-1379

ARL-TR-3826

June 2006

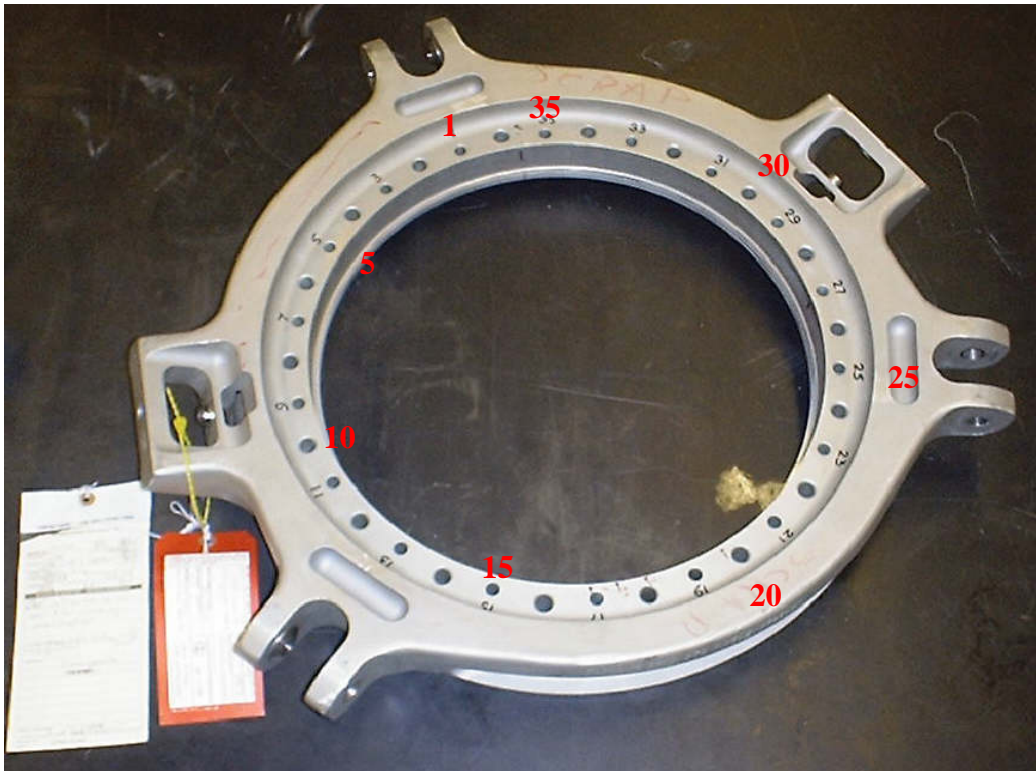
Figure 1. As-received component BCW-1379 swashplate rotating ring.

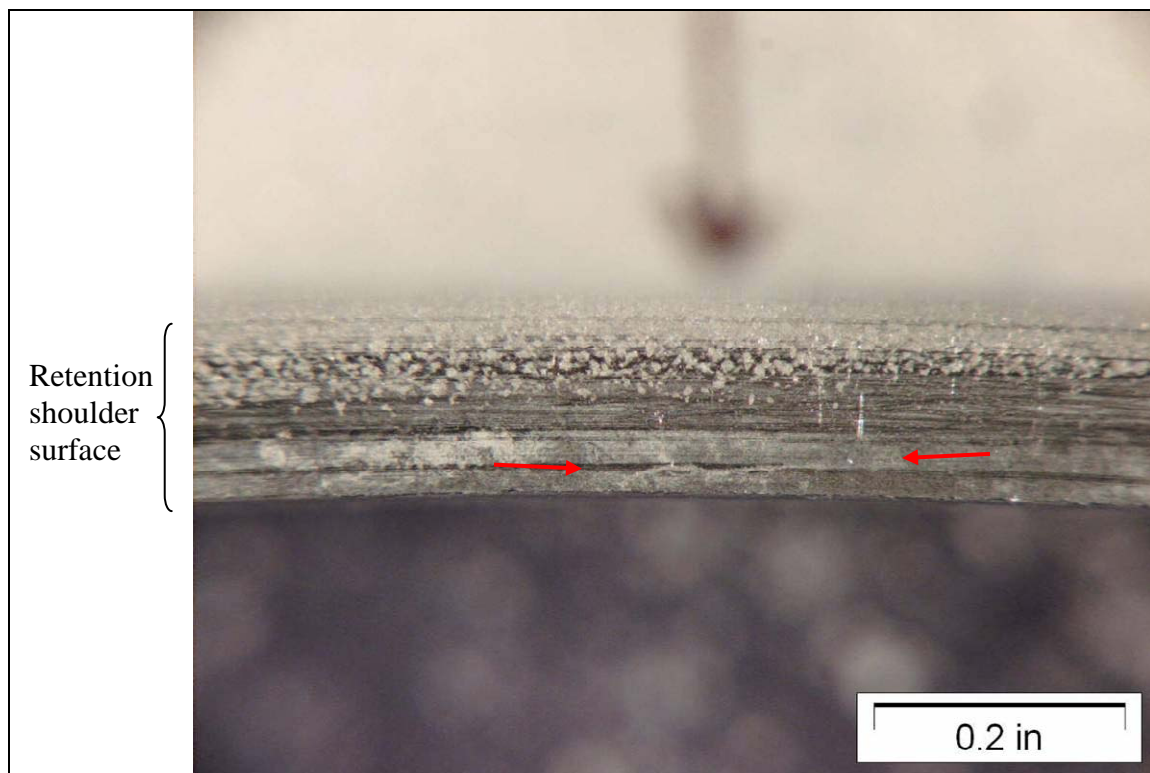
Figure 2. White light indication of the circumferential crack at hole 5.

The crack at hole 5 was atypical of the previous cracking observed on other rotating rings. There was no apparent fretting wear in the area. There did exist, however, a circumferential score line that ran along the path where the crack initiated. This score line extended approximately 3 in along the circumference in this area and is clearly visible in figures 2, 9, and 10. A similar score line was apparent at other locations around the circumference of the bearing retention shoulder surface. It appeared to be an impression left by the edge of the outer race of the mating bearing and the contact loading between the components. Although the bearing that mated with this rotating ring was not available for inspection, the team examined a similar bearing from another rotating ring. This “representative” bearing exhibited raised machining marks on the edges of the inner and outer races of the bearing. The crack at hole 5 was circumferential, approximately 0.35 in long, and only 0.015 in from the 16.19-in-diameter surface. It initiated and propagated circumferentially (see figures 10 and 11). The circumferential cracks observed on other rotating rings initiated near the outer edge of the wear step (approximately 0.90 in away from the 16.19-in-diameter surface) and quickly turned radially in favor of the service stresses on the component. To determine if the crack was the edge of a machining burr rolled over by subsequent shot peening, a section was made through one end of the crack and examined metallographically. Figure 12 shows the resulting cross section clearly indicating that the crack

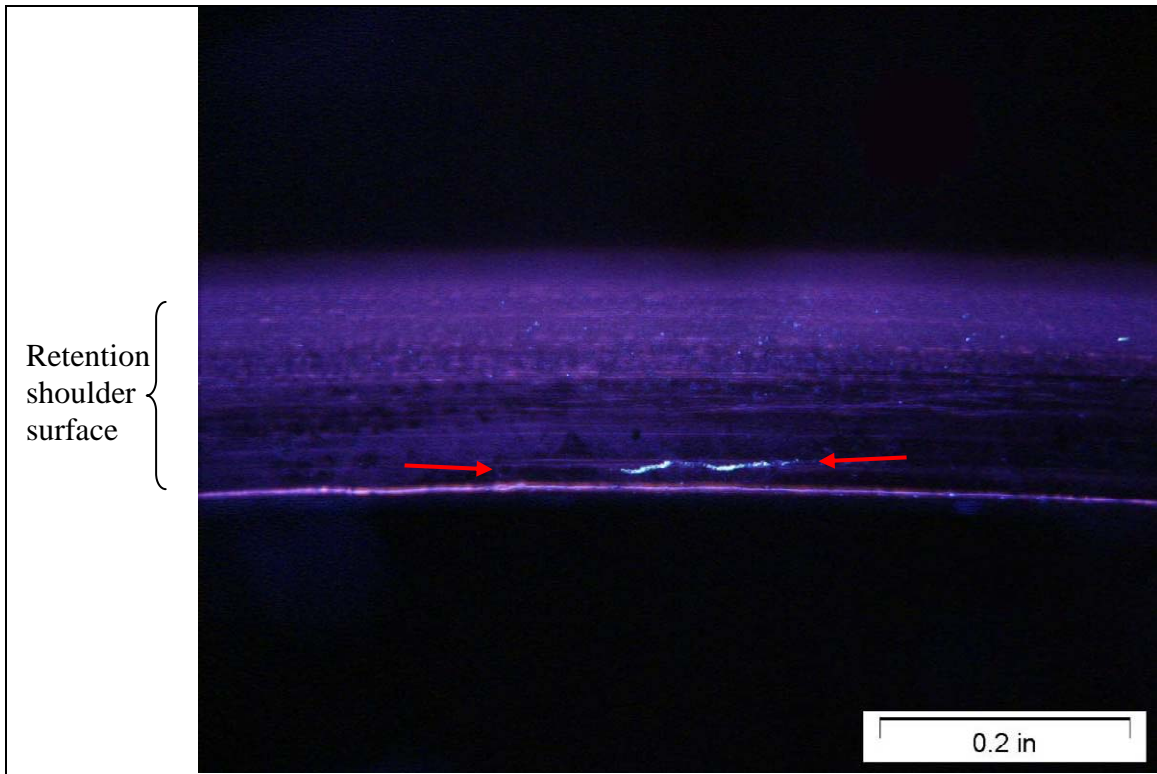
Figure 3. Black light indication of the circumferential crack at hole 5.

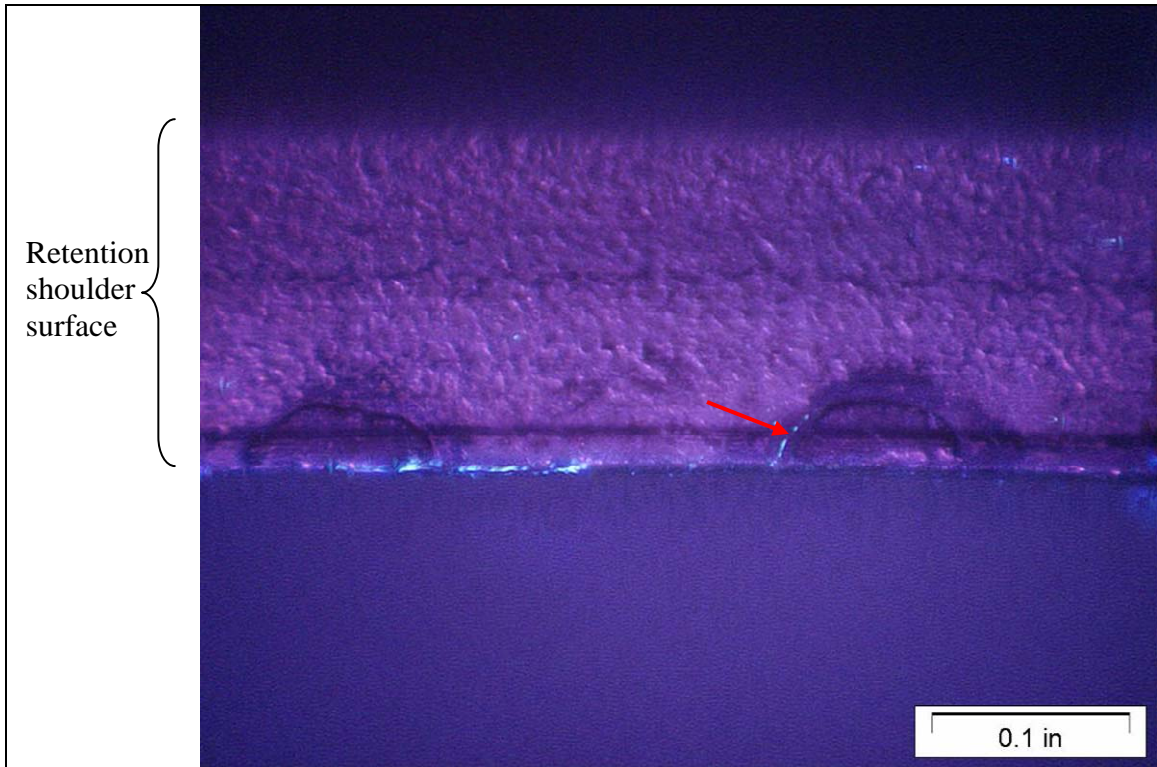
Figure 4. Black light indication of the crack at the thumbnail fretted area at hole 30.

The crack at hole 30 was similar to some of the cracks observed on the other rotating rings. This crack formed at the edge of a raised fretted thumbnail induced by damage incident to the 16.19-in-diameter surface from an unknown source. This crack can be observed in figures 4 and 15. The crack was very small, measuring approximately 0.035 in long \times 0.005 in deep. Due to its small size and apparent similarity with the cracks on the other rotating rings previously examined, no attempt was made to open this crack for fractographic examination. It was assumed that this crack initiated and propagated by fatigue as a result of localized high stresses due to the effect of the raised thumbnail on the load distribution between the rotating ring and the bearing. Pitting corrosion was observed at two locations in this area as well as of the 16.19-in-diameter surface. The pitting corrosion can be observed in figure 16 along with the raised fretted thumbnails. There were no cracks associated with the pitting sites. It is not believed that they are associated with the damage incident to the 16.19-in-diameter surface.

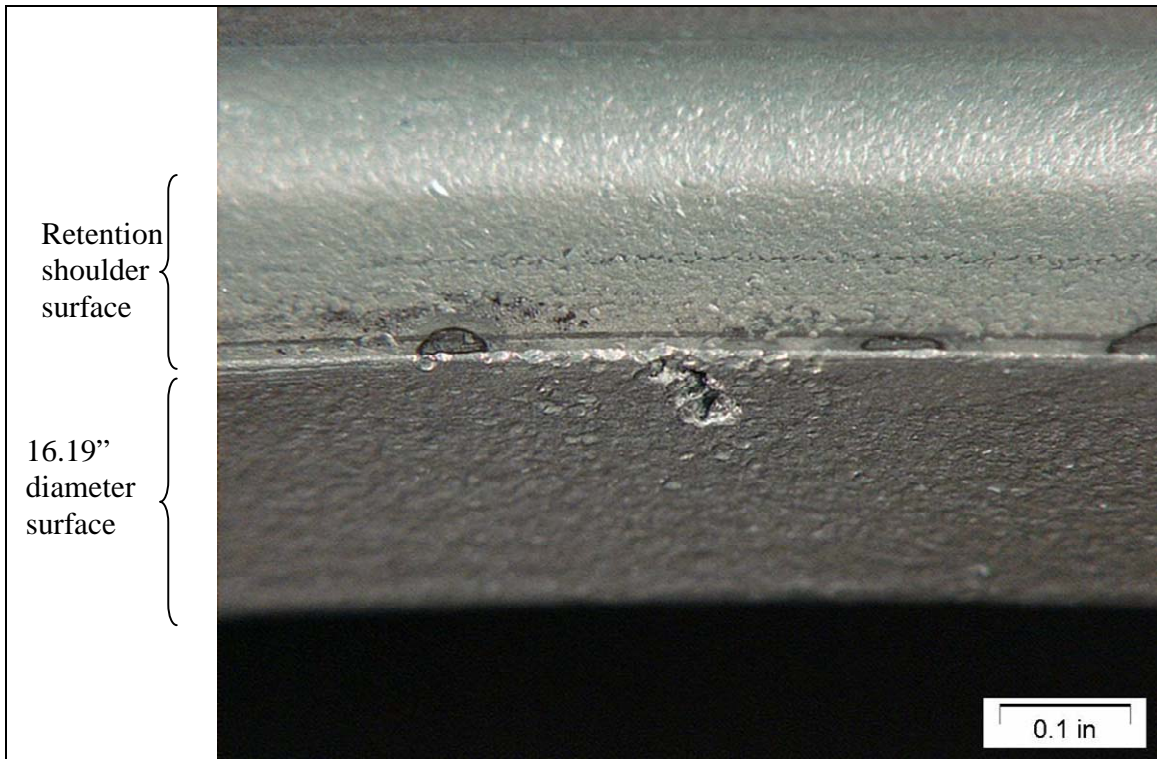
Figure 5. White light macrograph of the corrosive attack near hole 30.

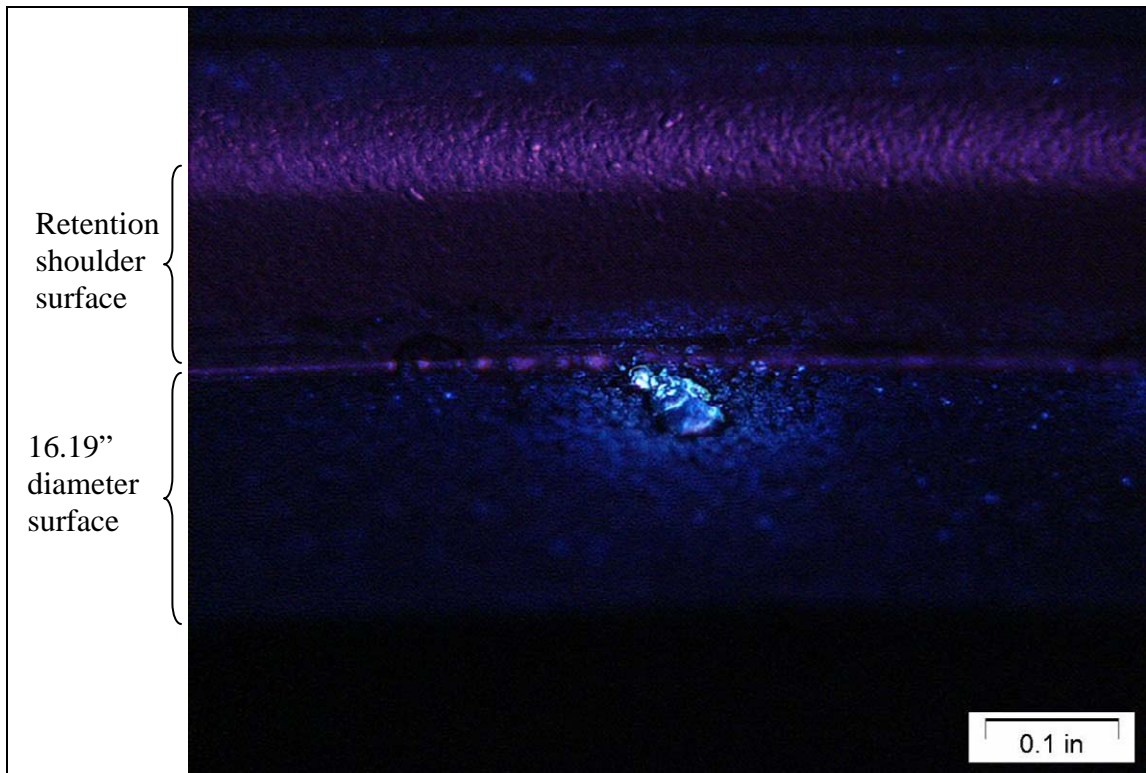
Figure 6. Black light macrograph of the corrosive attack near hole 30.

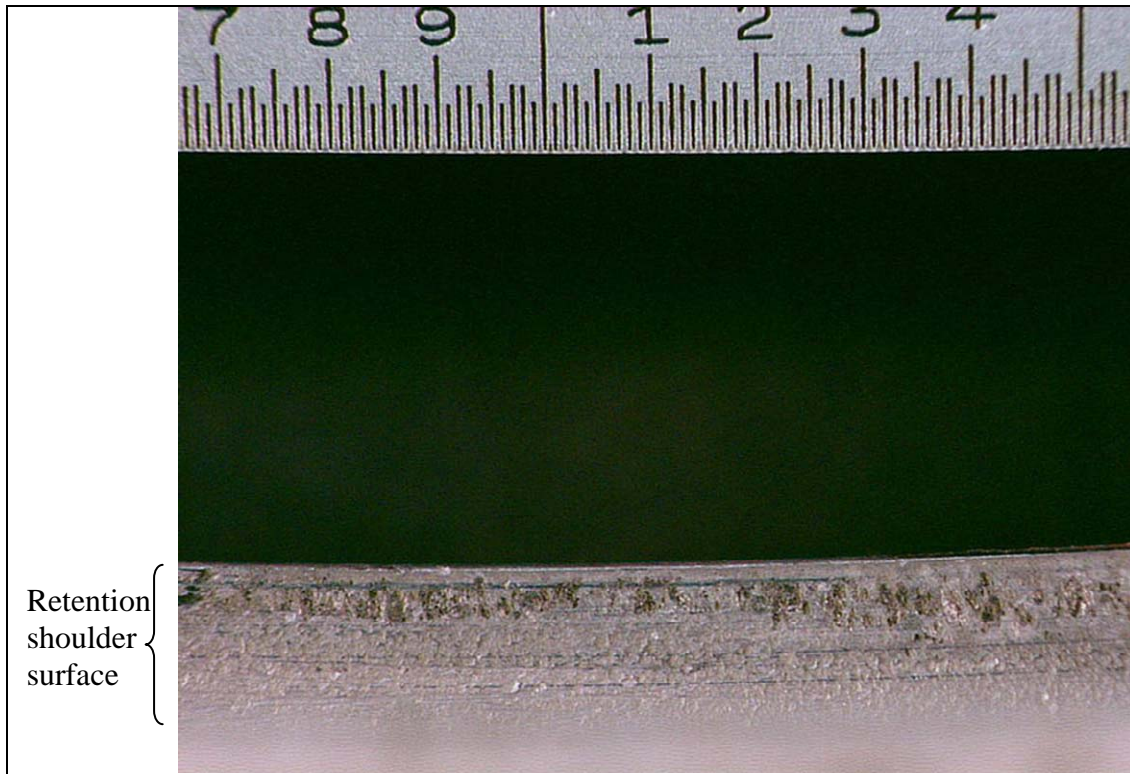
The bearing retention shoulders of all three rings were inspected visually and with light optical microscopy. For ring BCW-1379, cracks and crack measurements were verified at hole 5 and hole 30. The bearing shoulder wear pattern appeared discontinuous, with the most severe wear occurring between pitch link locations. At all other locations, the shot peening impressions appeared uniform and continuous. The discontinuous wear step was caused from contact with the swashplate bearing and the contact loads between the two components. The other two rings had a much more severe, continuous wear step around the bearing retention shoulder.

Figure 7. Typical fretted area on the bearing retention shoulder (hole 9).

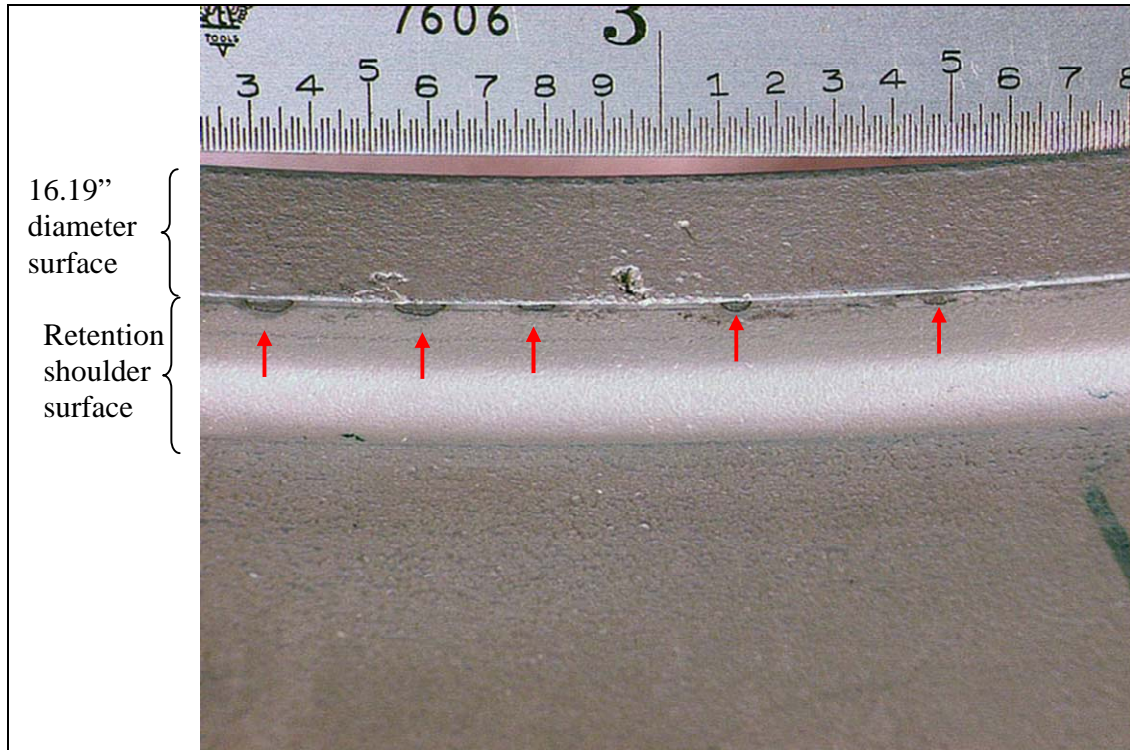
Differences in the severity of the wear step were most likely due to the loads applied to the components, slight differences in dimension, and time in service coupled with the service conditions. Although the wear step on BCW-1379 appeared less severe than the wear step observed on the other two rings, examples of similar damage mechanisms were apparent. Significantly fretted areas were observed at holes 3–4, 6, 9, 15–17, 26, 27, 32, and 35. An example of a significantly fretted area is depicted in figure 7. Raised areas where damage on the 16.19 in diameter caused material to be pushed up on the bearing retention shoulder could be observed at holes 9, 11, 13, 16, 20, 23, 30, and 34. These raised areas only had considerable fretting at holes 20, 30, and 34; however, the raised areas at hole 30 can be observed in figures 8 and 16. The damage to the 16.19-in-diameter surface is highlighted for clarity in figure 9. Compare figure 9 with figure 8. The damage at the left in both photos is the most obvious.

Figure 8. Typical raised fretted areas associated with 16.19-in surface damage (hole 30).

Elimination of the procedure and/or tool causing the damage on the 16.19-in-diameter surface seems prudent. This is most likely occurring at overhaul and is the most prominent cause of localized high stresses on the bearing retention shoulder of the rotating rings.

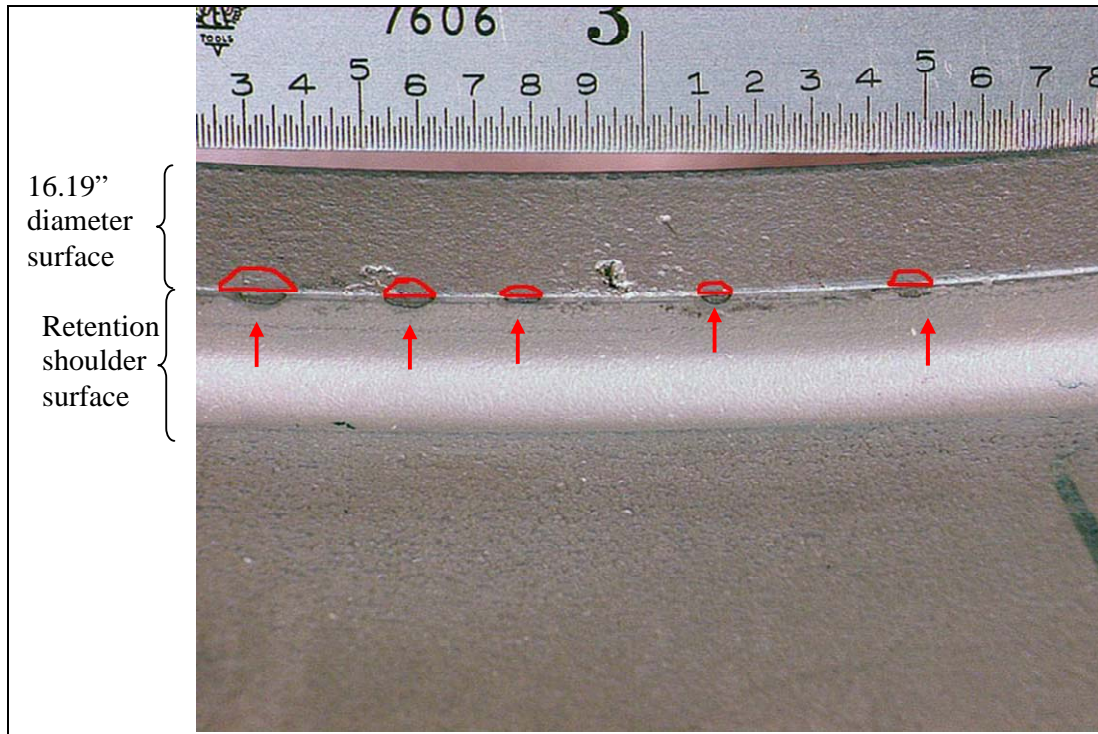
Figure 9. The damage causing the raised fretted areas associated with 16.19-in surface.

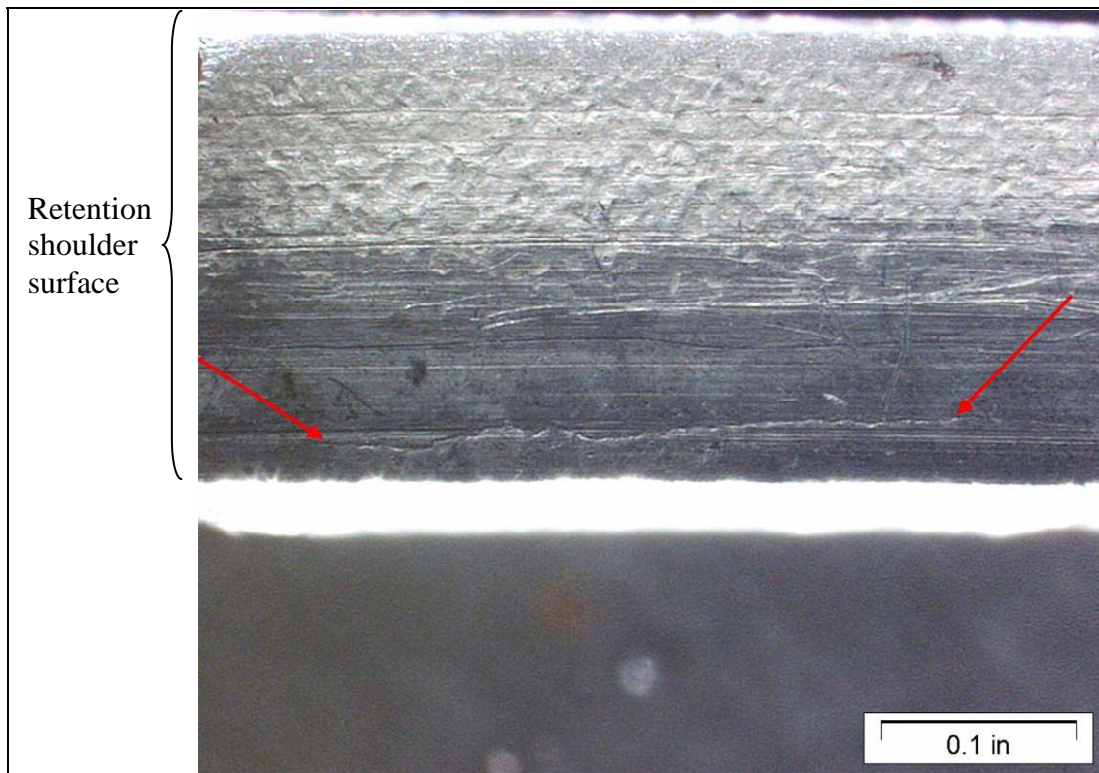
Figure 10. Photograph 1 of the circumferential crack at hole 5.

Although it is likely not the most common cause of local high stresses, it would seem that the surface finish and chamfer on the mating bearing should be scrutinized to determine if they detrimentally affect the rotating ring under contact and service loading.

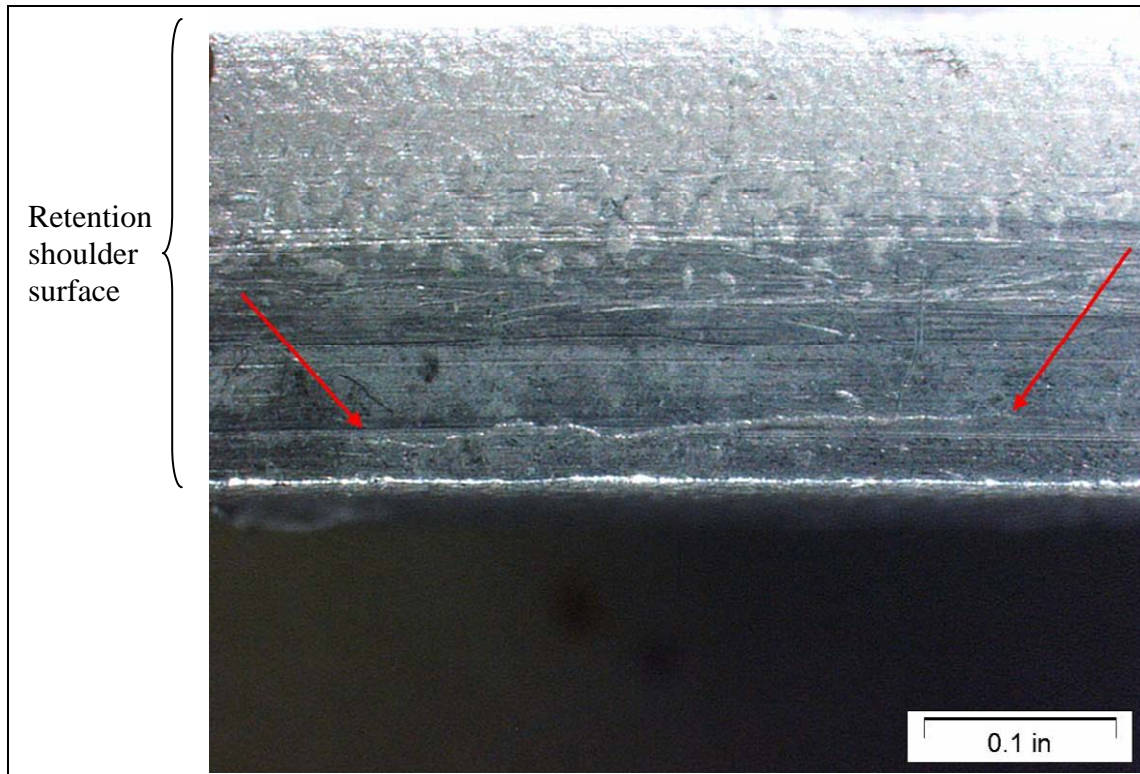
Figure 11. Photograph 2 of the circumferential crack at hole 5.

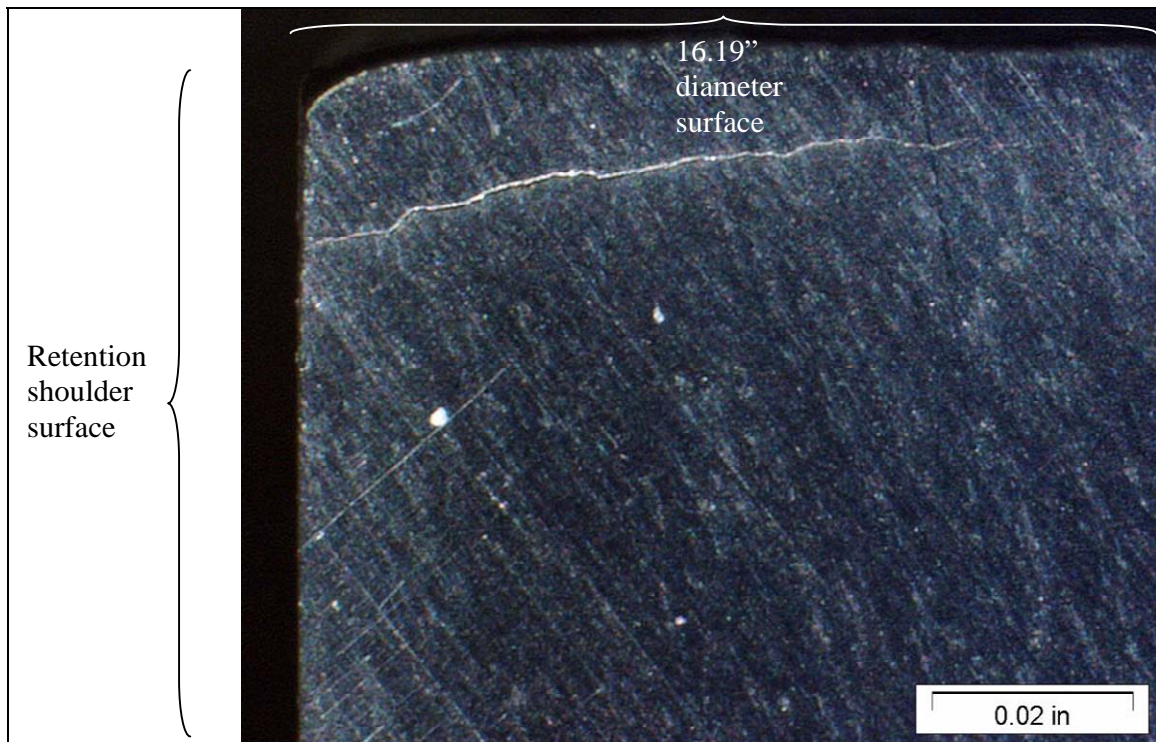
Figure 12. Cross section of the crack at hole 5.

had considerable depth and was not simply a rolled-over burr. It can also be seen in this figure that the crack roughly paralleled the 16.19-in-diameter surface and would have likely propagated considerably farther in both the axial and circumferential directions before contacting the exterior surface of the component. The crack was then opened for fractographic examination.

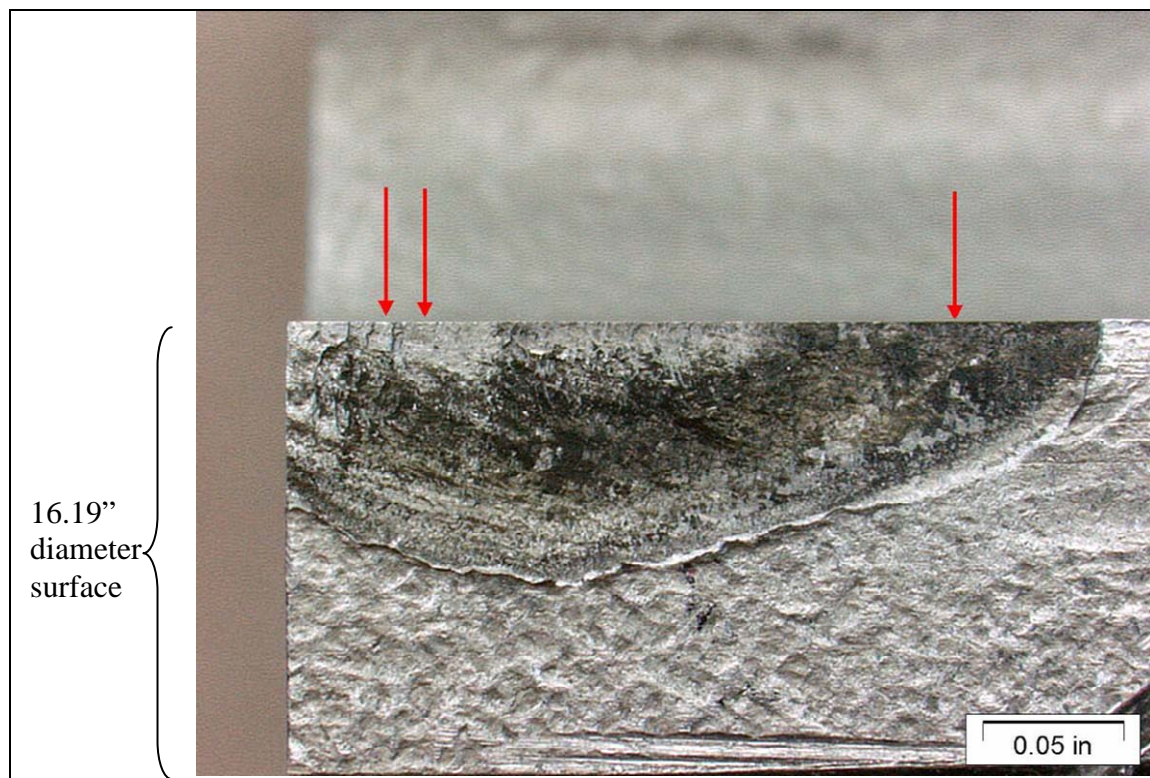
Examination of the crack's fracture surface revealed at least three origins, all initiated by fatigue on the bearing retention shoulder surface. The beach marks and radial lines suggested it was unlikely that more origins existed within the material consumed during metallographic preparation, prior to the crack being opened (observable in figures 13 and 14). The crack propagated by fatigue from these three origins to a total depth of 0.090 in and a total estimated length of 0.350 in. Figures 13 and 14 depict the fracture surface with red arrows and lines indicating the crack origins and propagation fronts, respectively. A black product was visible on approximately half of the fracture surface; this product was analyzed with Energy Dispersive Spectroscopy (EDS) (and discussed within the SEM section of this report). The depth of the wear step at hole 5 was approximately 0.001 in. No mechanical damage was noted on the 16.19-in-diameter surface in the area of the crack and no other anomalies were observed in this area.

Figure 13. Fractograph of the opened crack at hole 5 (arrows indicate origins).

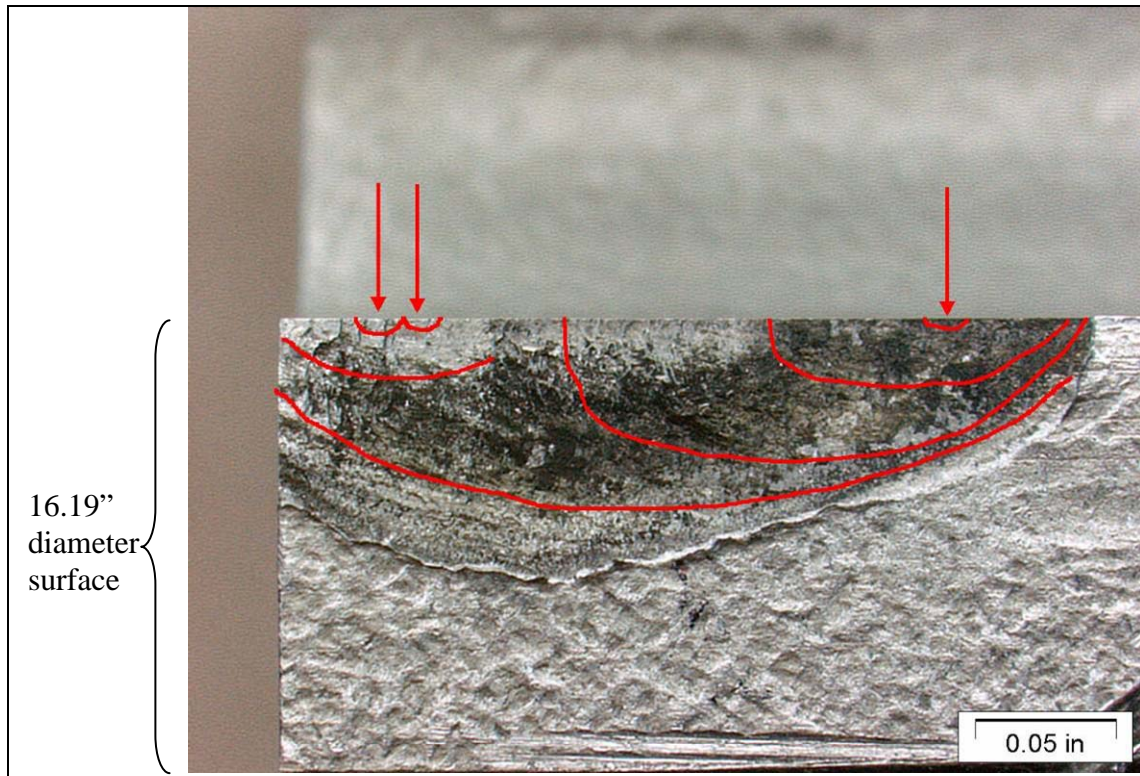
Figure 14. Fractograph of the opened crack at hole 5 with propagation lines.

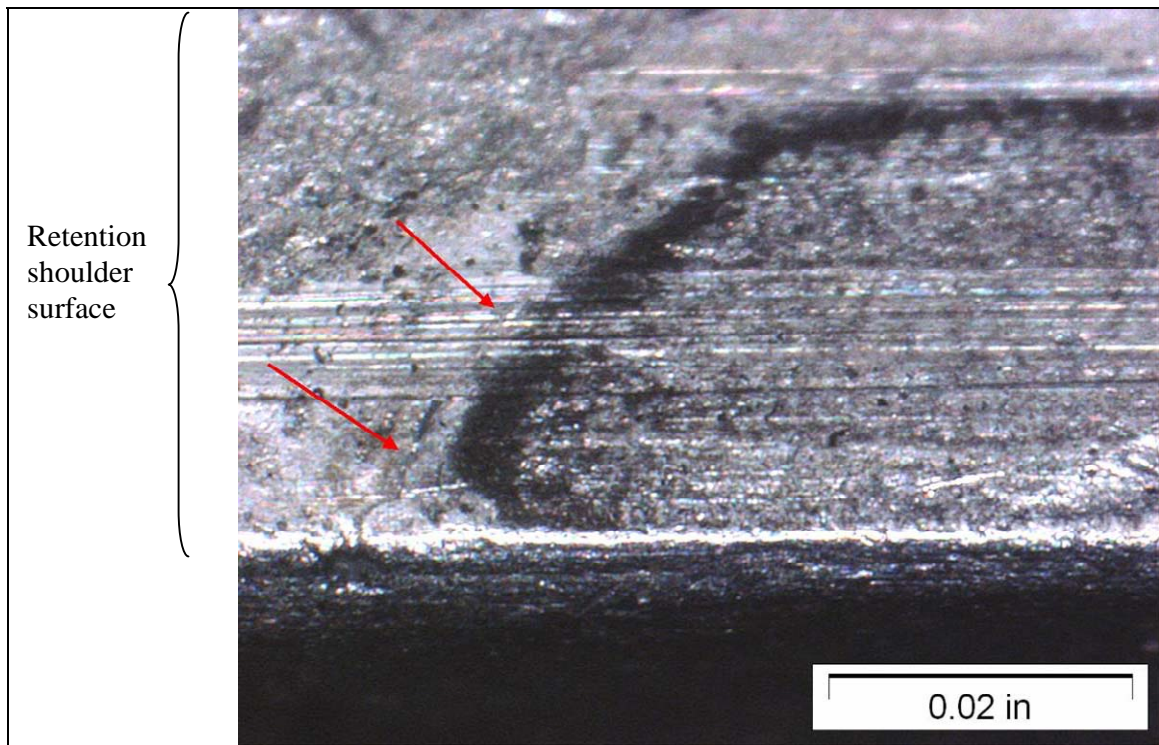
Figure 15. Crack at a raised fretting site located at hole 30.

The crack along the edge of the raised thumbnail area initiated by fretting fatigue and localized high stresses. The localized high stresses were due to the reduced contact area the approximately 0.002-in high thumbnail area created. The raised area appeared to be a direct result of impact damage on the 16.19-in ID of the rotating ring from an unknown source, possibly at overhaul. The impact damage on the ID pushed material into the rotating ring, subsequently causing a bulge on the mating surface shoulder between the ring and the bearing.

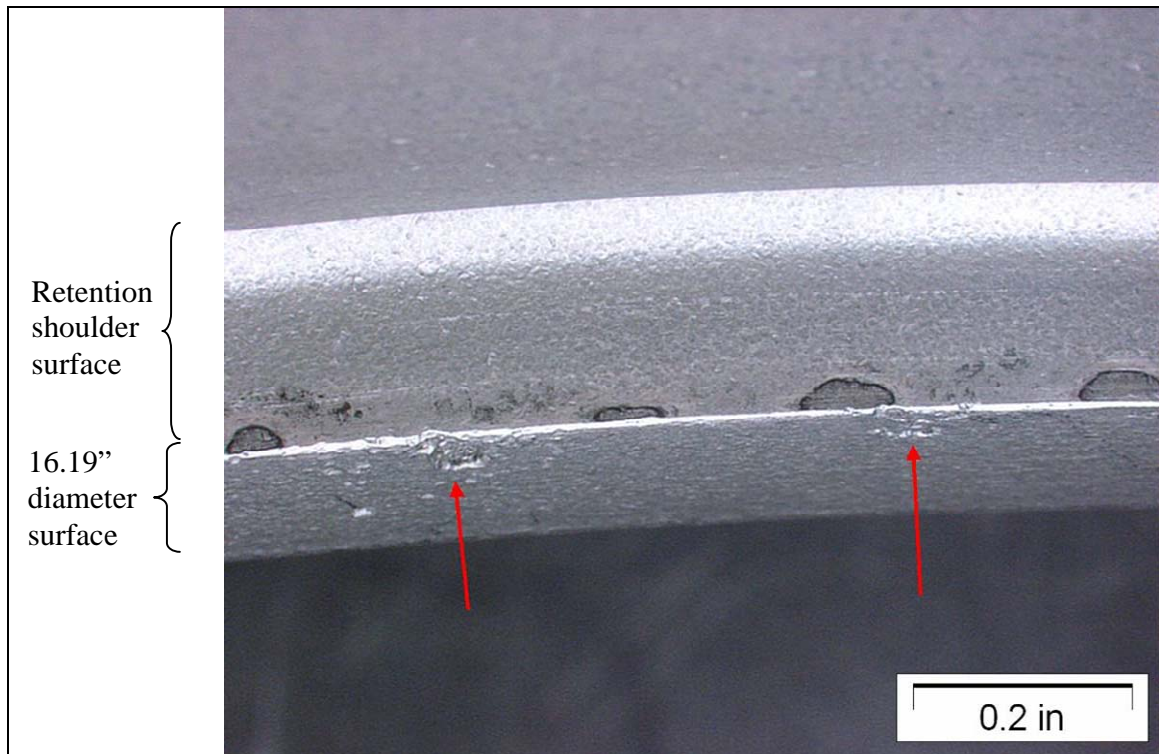
Figure 16. Corrosion pits and raised fretted areas at hole 30.

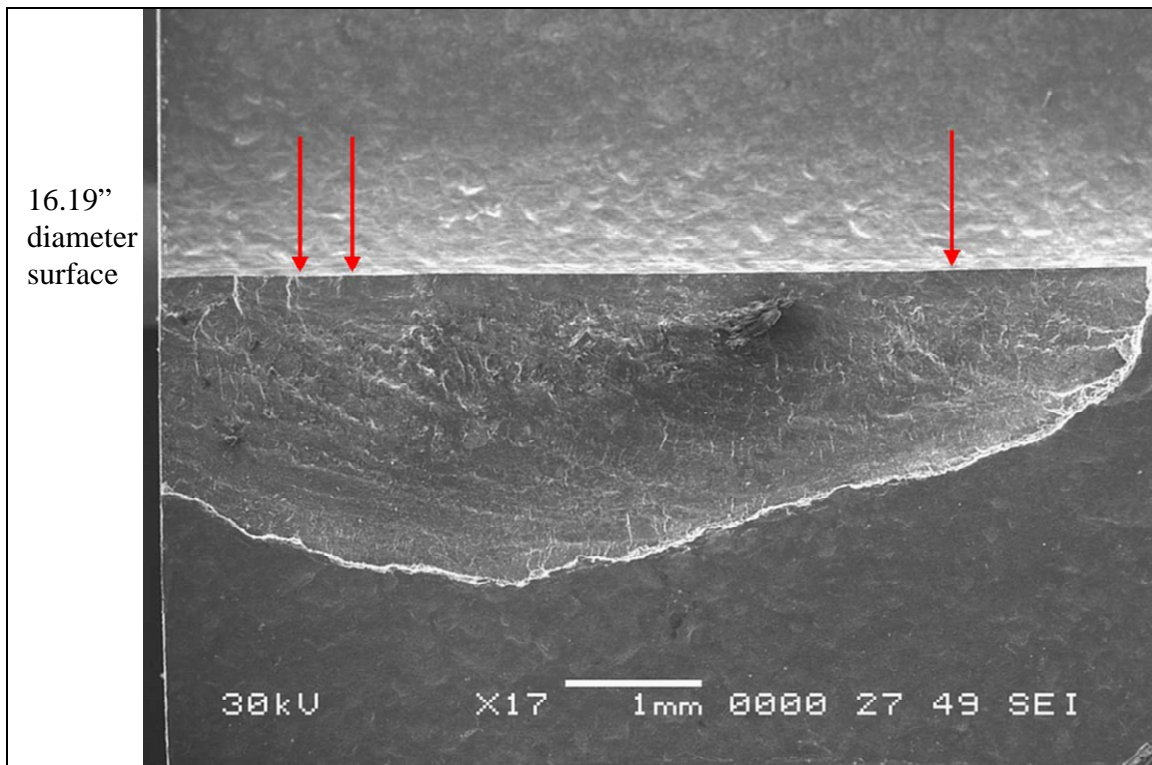
SEM utilizing a JEOL-JSM 6460-LV was performed to investigate the fracture surfaces in greater detail. The crack at hole 5 is depicted in the electron fractograph in figure 17. At closer inspection, evidence of cyclic fatigue crack propagation was present (figure 18). The fracture morphology was transgranular throughout the cracked region. EDS was utilized to analyze a dark product on the fracture surface. The product appeared to have high peaks for oxygen and aluminum, indicative of oxidized aluminum and that this crack either took a long time to form or formed quite a while ago. No more specific information about the age of the crack could be determined. This spectrum can be observed in figure 19. Aside from the wear step and the score line previously described, there was no significant mechanical damage or corrosion present at the origins.

Figure 17. SEM fractograph of the crack at hole 5.

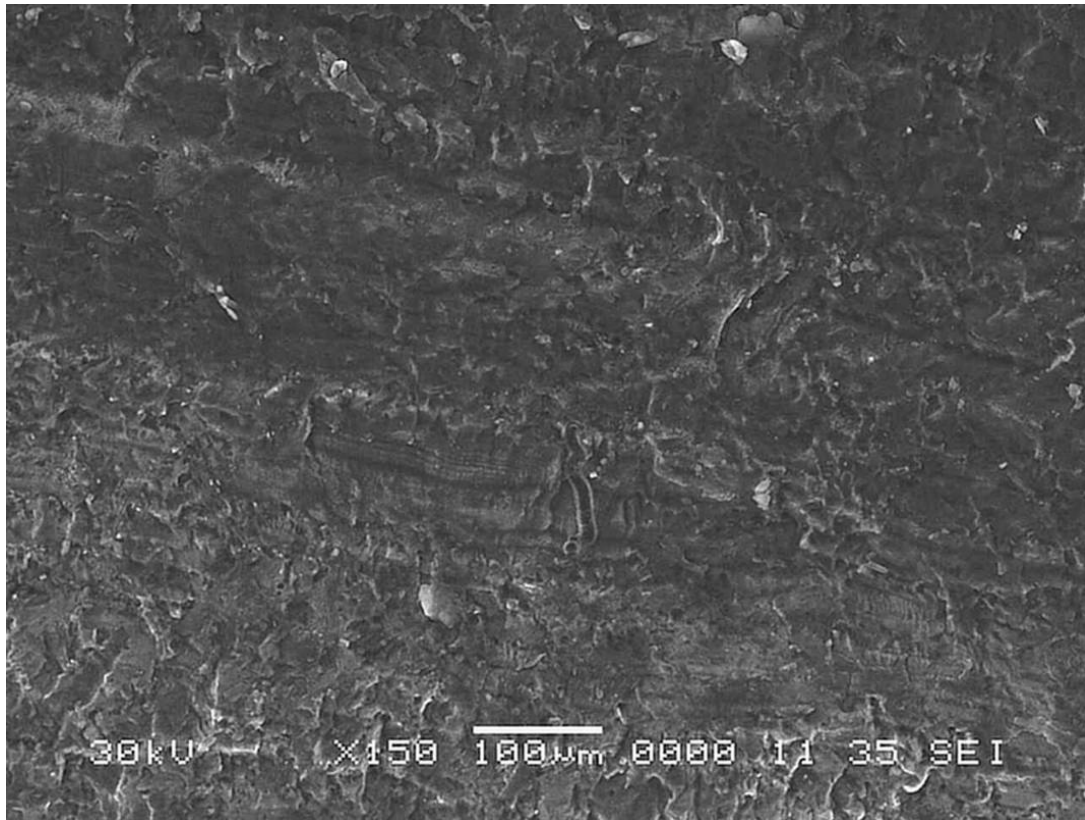
Figure 18. SEM micrograph depicting cyclic crack propagation at hole 5.

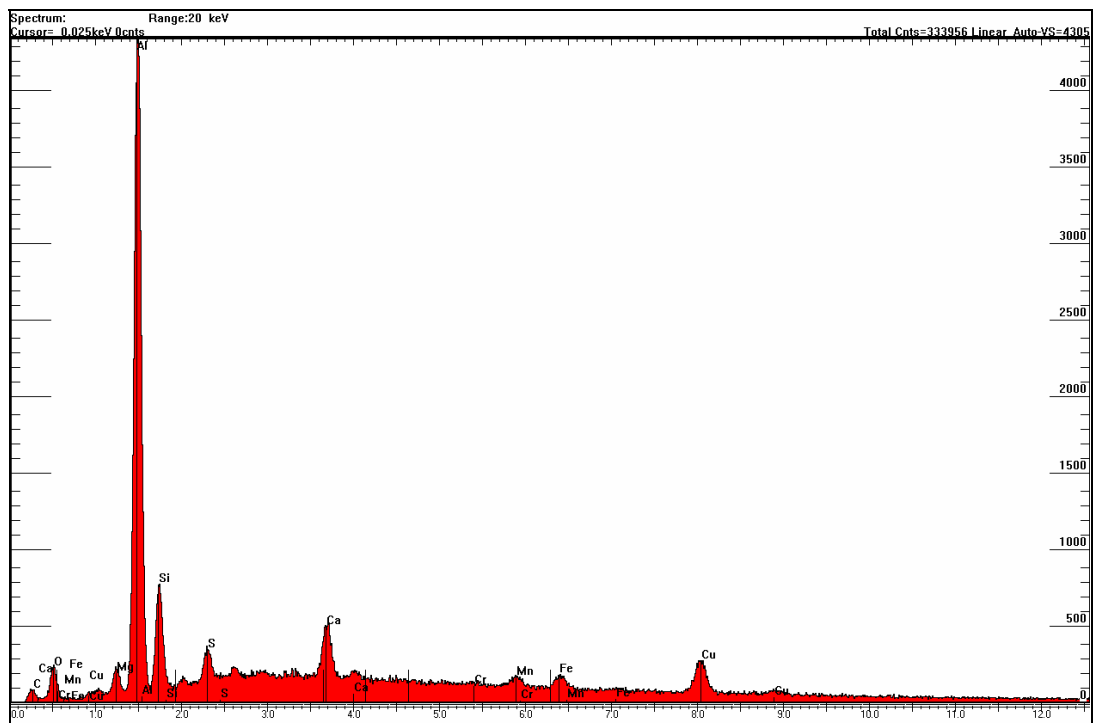
Figure 19. EDS spectrum from the black product on the fracture surface at hole 5.

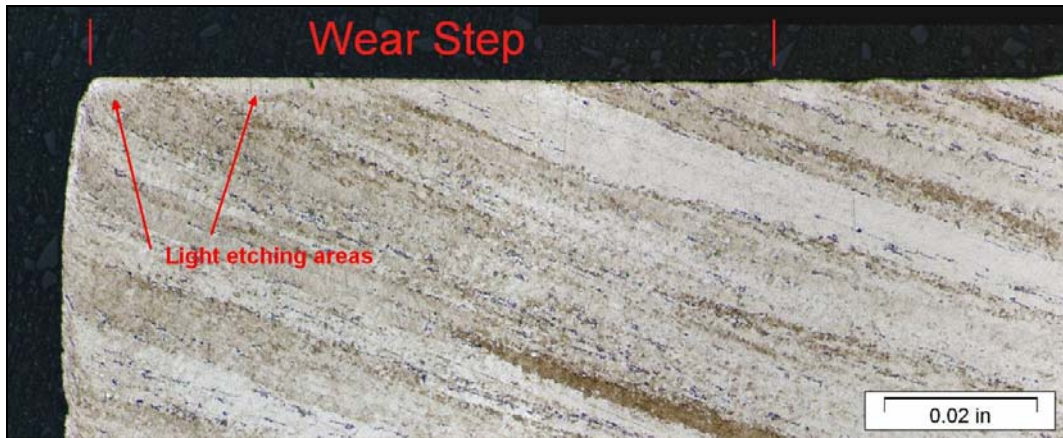
Figure 20. Microstructure near the wear step.

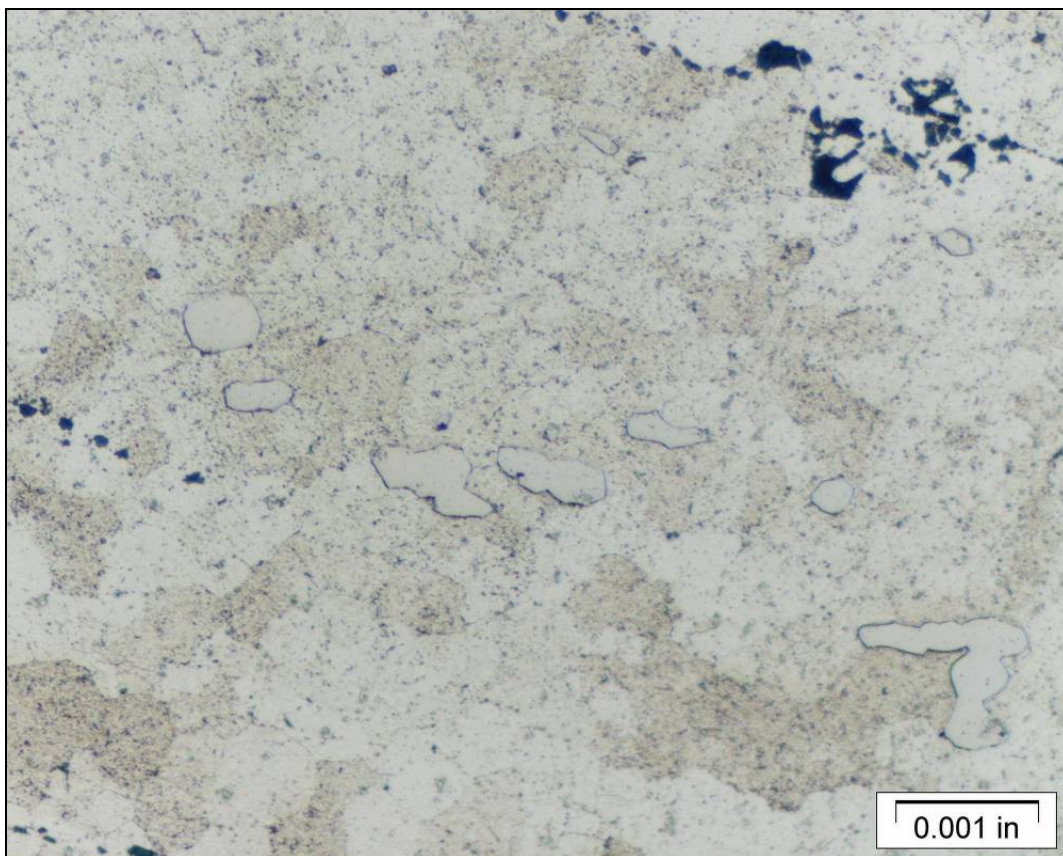
A radial cross section was prepared through the bearing retention shoulder. The section was ground and polished through 0.025- μm noncolloidal silica. Subsequently, the specimen was etched with Keller's reagent. The microstructure of the rotating ring material was found to be consistent with 2014-T6 aluminum. The depth of the wear step was believed to be at its maximum in this cross section and measured approximately 0.001 in. The onset of strain hardening of the material below the wear can be observed as a light etching effect. The microstructure beneath the wear step can be observed in figure 20. The typical microstructure of the base material is depicted in figure 21. No other abnormalities were observed. A radial cross section was also evaluated for the grain flow induced by forging. The section was polished and macro-etched with NaOH. Forging flow lines were observed generally following the contours of the component, confirming that the component was forged as required by the engineering drawing. The grain flow pattern is shown in figure 22.

Figure 21. Typical microstructure of aluminum 2014-T6 base material.

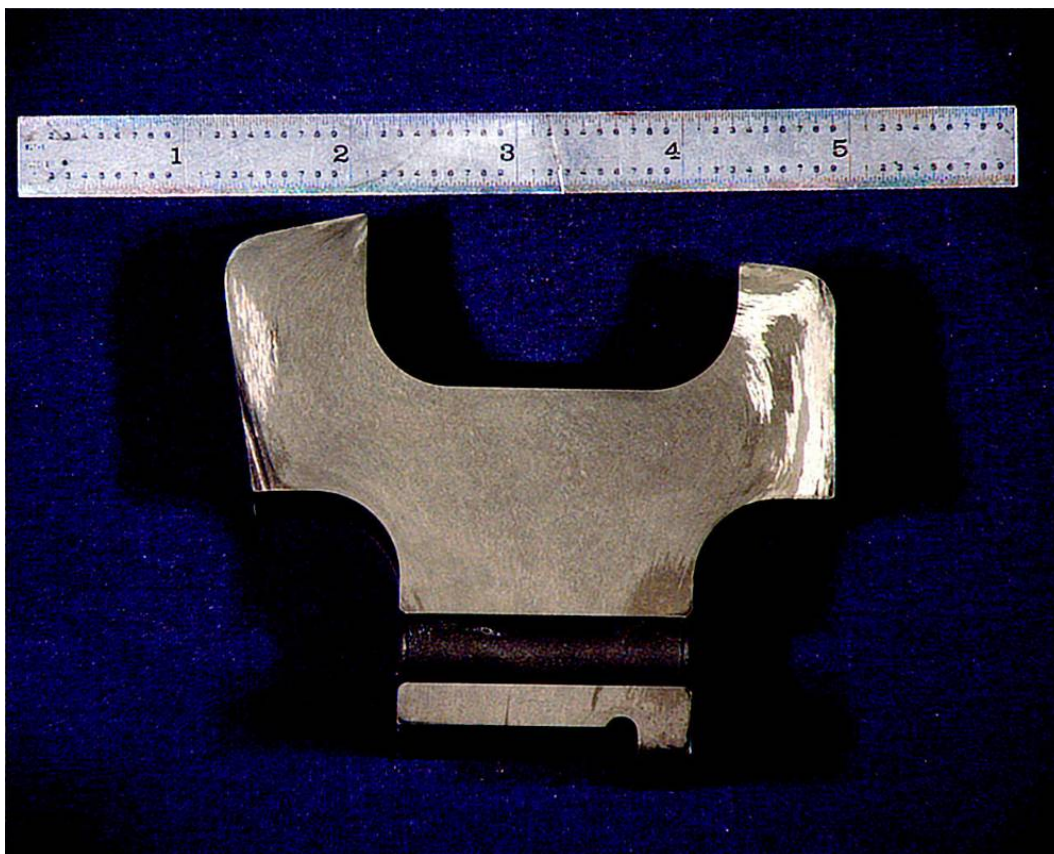
Figure 22. Macro-etch of a radial section depicting forging flow lines.
